ARCUS

ARBORICULTURAL REPORT TO BS5837:2012

SWANSEA NORTH GREENER GRID PARK

FOR STATKRAFT UK LTD

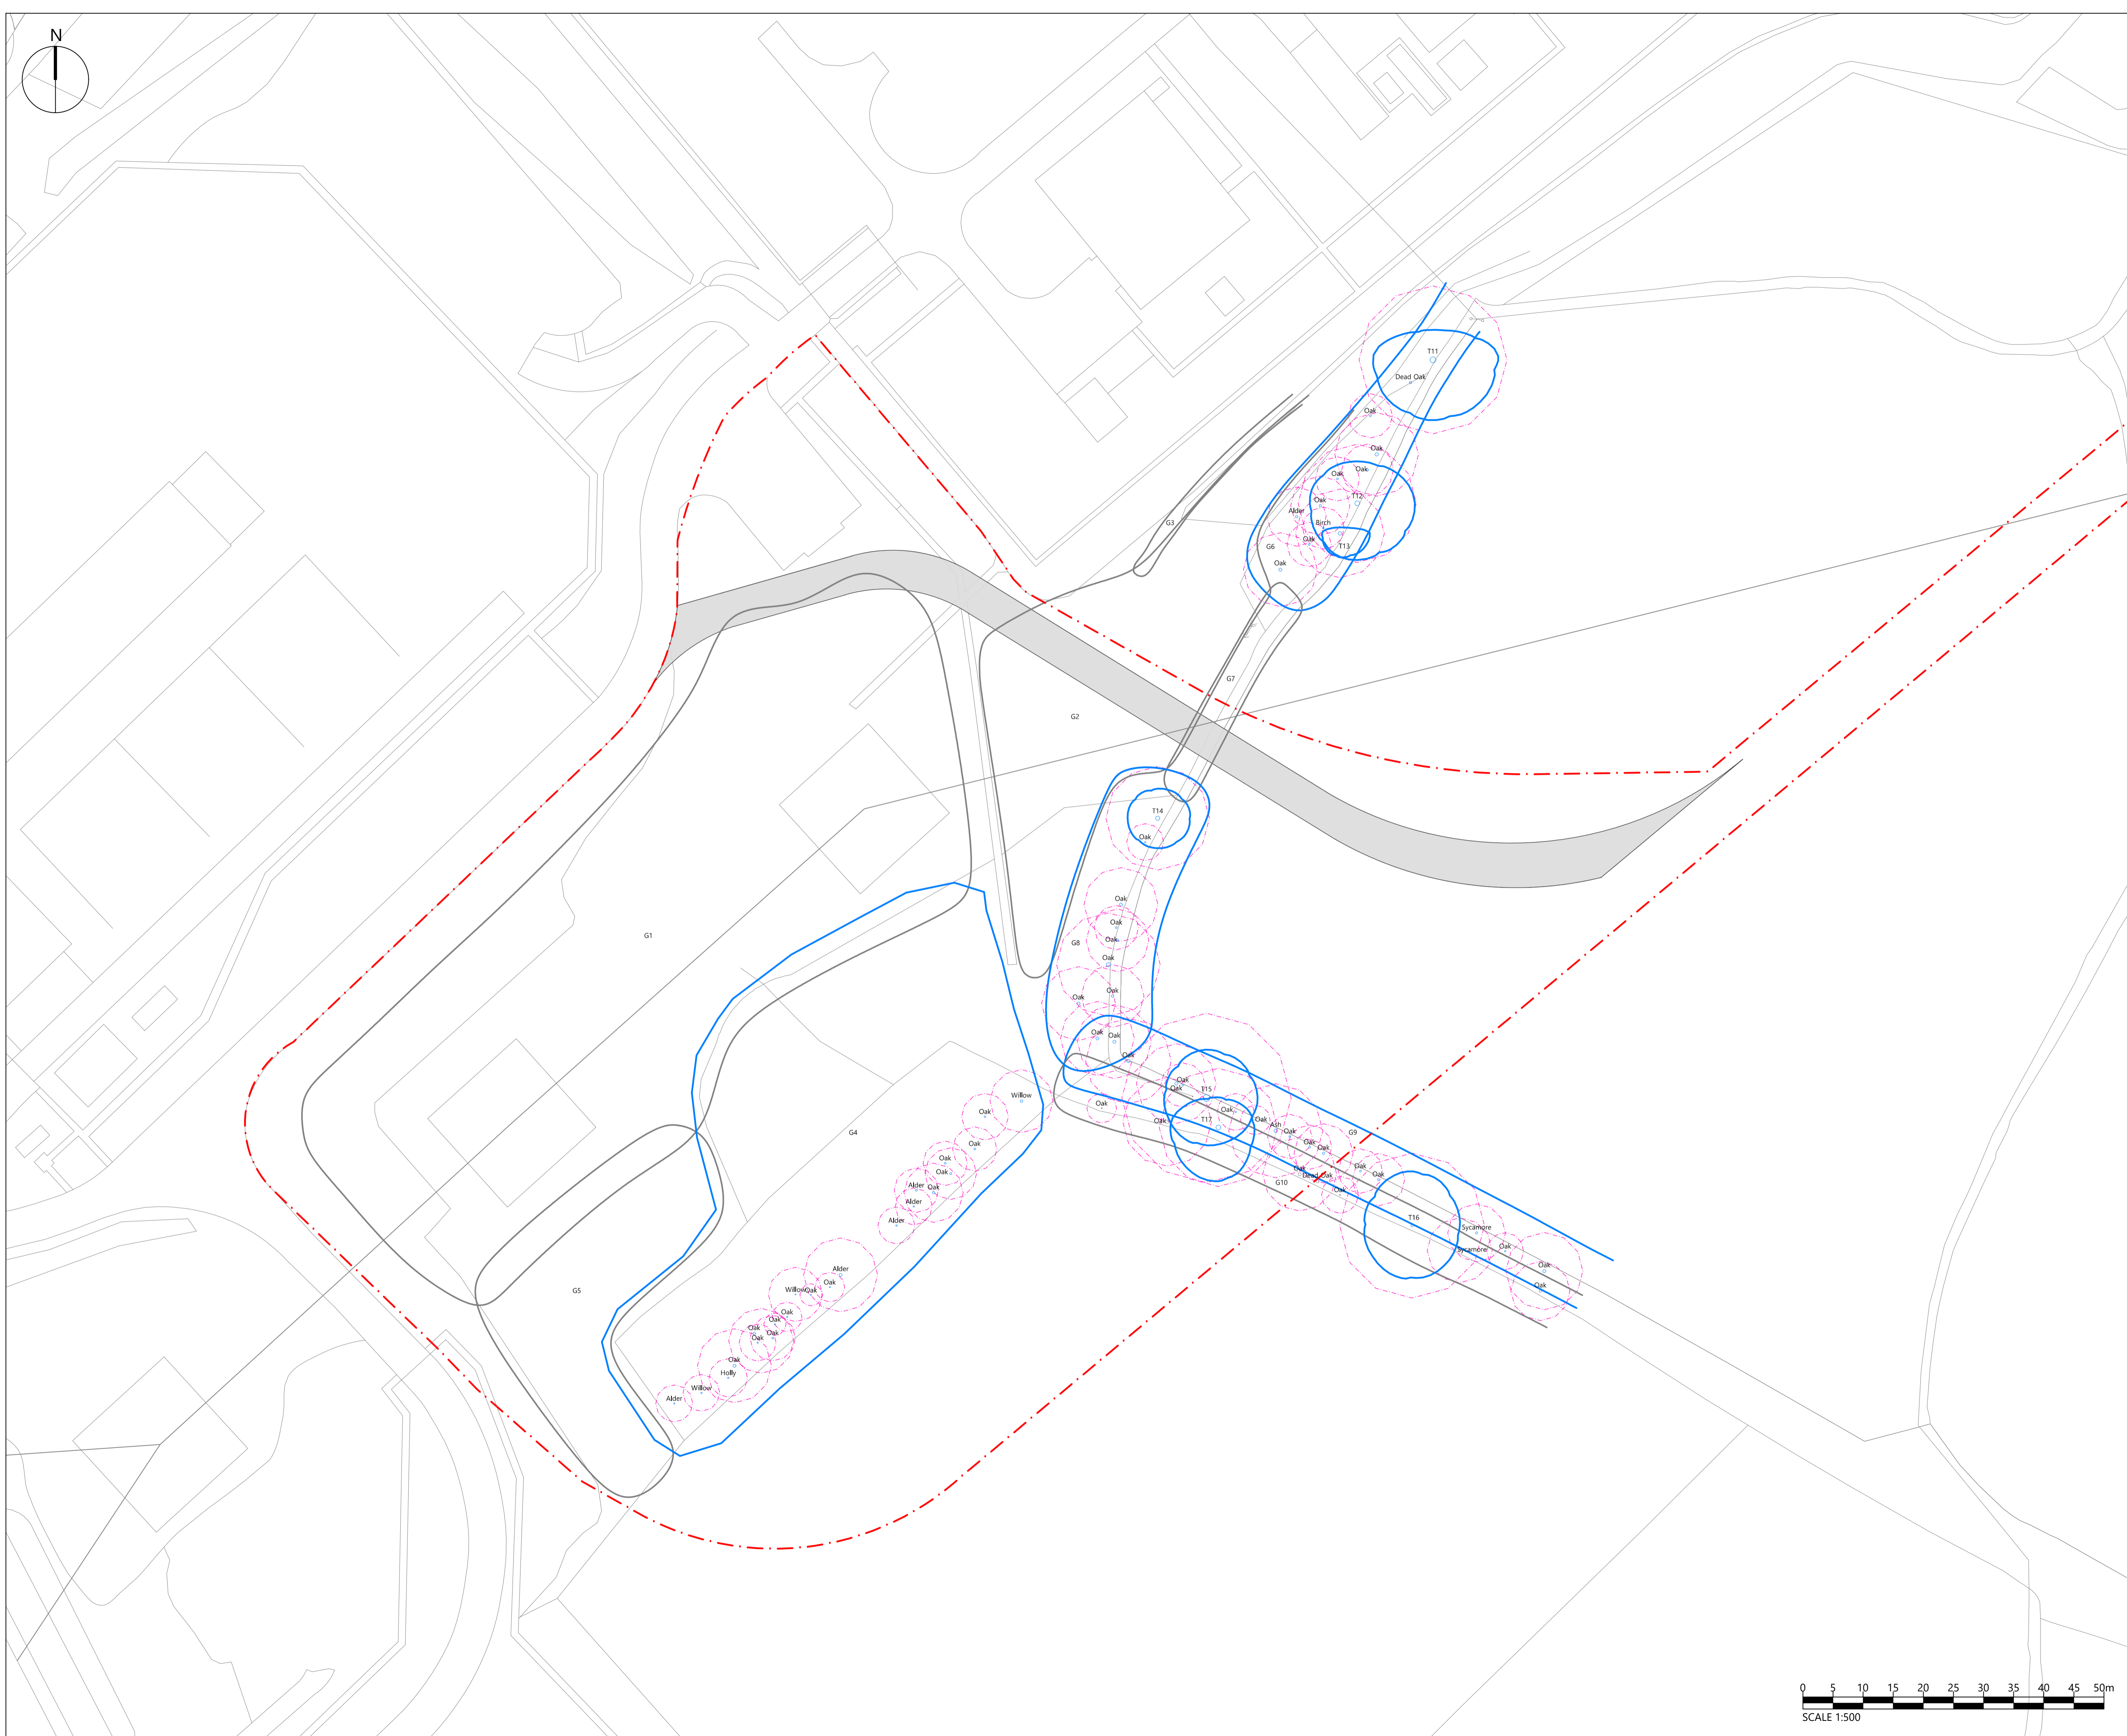
Appendix 4: Tree Constraints Plan

The tree survey revealed 17 items of woody vegetation, comprised of 10 tree groups or hedges and 7 individual trees.

Of the surveyed trees: 4 tree groups and 7 individual trees are retention category 'B', and 6 tree groups or hedges are retention category 'C' (explanatory details regarding the retention categories are included at Appendix 2).

The tree Root Protection Area (RPA) detailed on the Tree Constraints Plan at Appendix 4 has been used as a layout design tool, to inform on the area around a tree where the protection of the roots and soil structure is treated as a priority.

The RPA for each tree has been plotted as a polygon centred on the base of the stem. Due to the presence of roads, structures, topography (and past tree management) the RPA is likely to be a simplified representation of the tree roots actual morphology and disposition. However, detailed modifications to the shape of the RPA would largely be based on conjecture and so have been avoided.

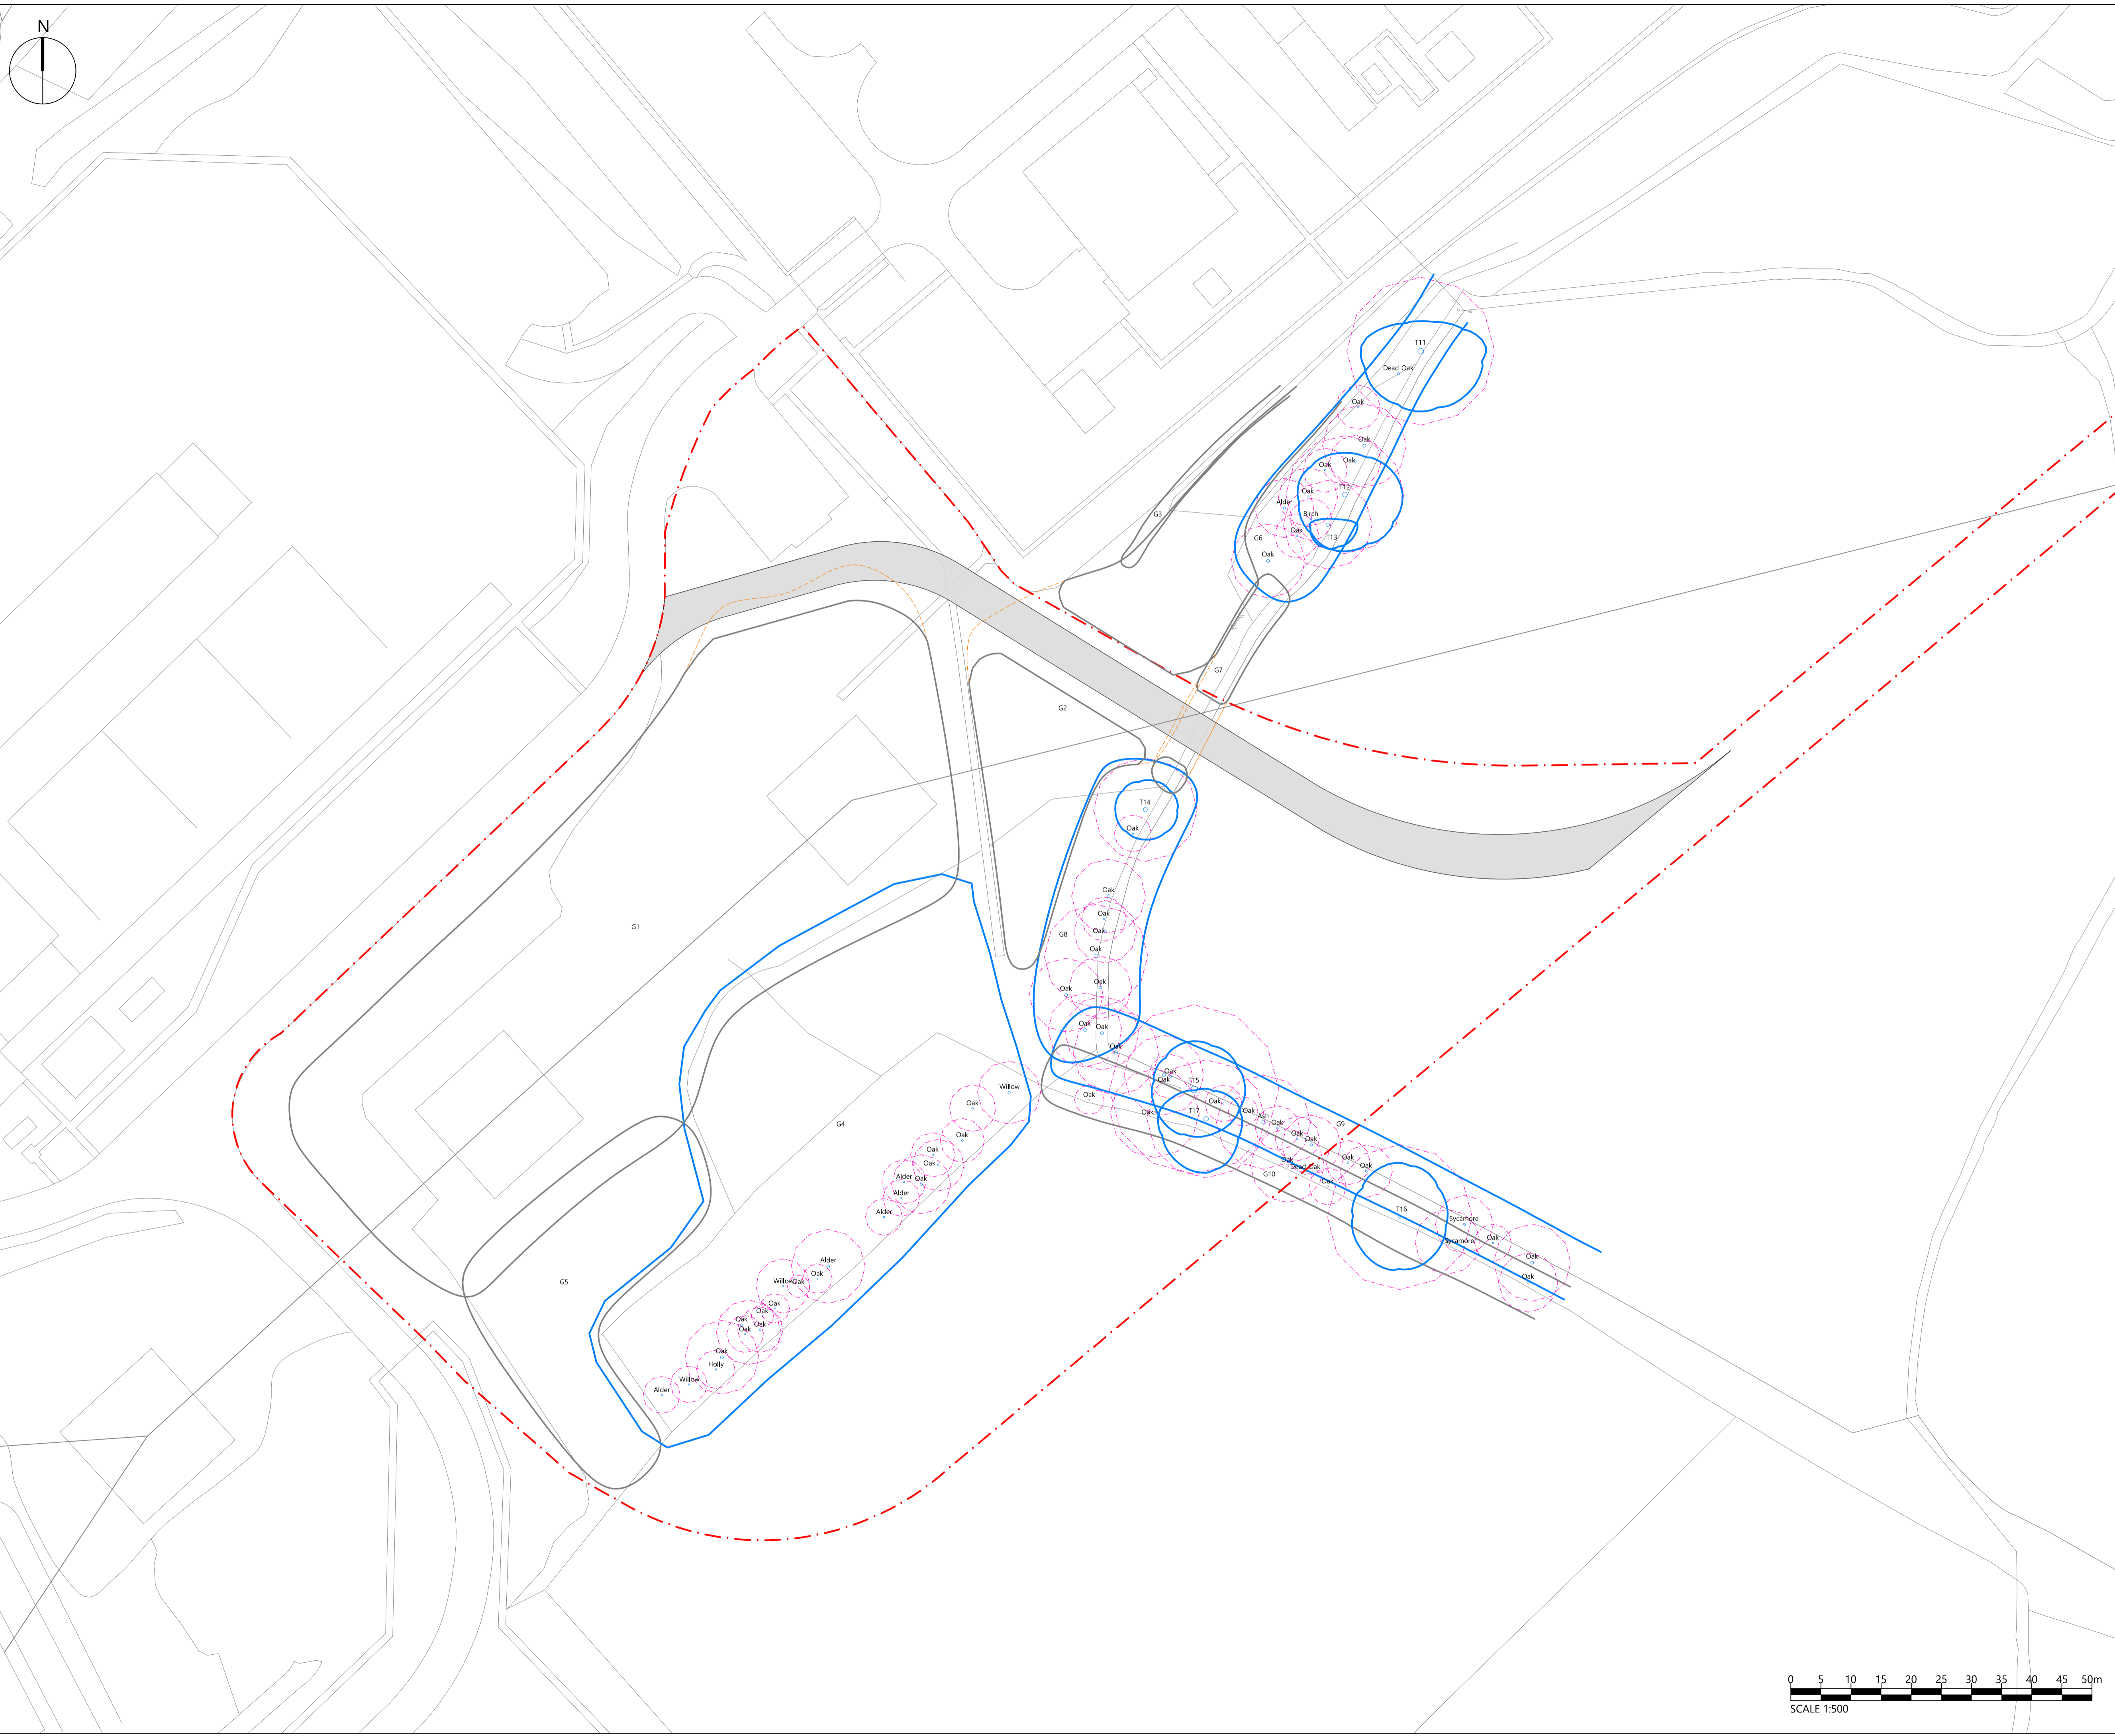
Appendix 5: Tree Impacts Plan

From assessing the new development proposals, the partial removal of 3 tree groups will be required as they are situated in the footprint of the development or their retention and protection throughout the development is not suitable.

The tree groups that require partial removal are G1, G2 and G7, they are comprised of low value young to semi mature natural regeneration or recent plantings and their partial removal will have little negative impact.

The tree Root Protection Area (RPA) detailed on the Tree Plans at Appendix 4 and 5, has been used as a layout design tool, to inform on the area around a tree where the protection of the roots and soil structure is treated as a priority. As such, no significant negative indirect impacts have been identified.

The retained trees may require protection by fencing in accordance with BS 5837: 2012, during the construction phase.

If required by the Local Planning Authority, an associated Arboricultural Method Statement, detailing protective fencing specifications and construction methods close to the retained trees can be provided.
