Red John Pumped Storage Hydro Scheme

Volume 5, Appendix 6.5: Reptile
Survey Report

ILI (Highlands PSH) Ltd.

November 2018

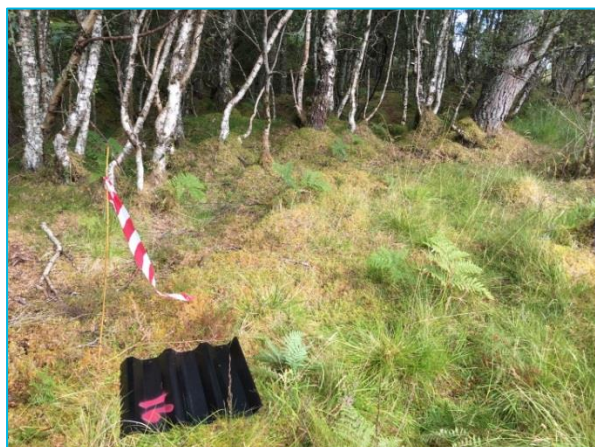
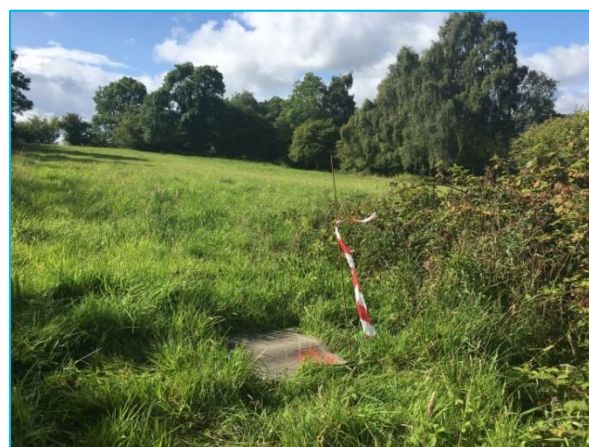
6.2.8 Photos 6.1 and 6.2 below show a corrugated metal tile on the edge of semi-natural woodland in survey Area A and a bitumen-backed tiled beside dense scrub in Area F.

- 6.2.5 A total of 130 bitumen-backed tiles and 18 corrugated metal sheets were placed across six areas of suitable habitat within the footprint of the Development and the immediate surrounds. The locations of the six survey areas are shown on Figure 6.5.1. A brief description of each area is provided in Table 6.2, including the number of tiles placed in each.
