Appendix 7.4: Peat Landslide Hazard and Risk Assessment

Appendix 7.4 - Peat Landslide Hazard and Risk Assessment Loch Liath Wind Farm

20-LUC-007-D-001v02

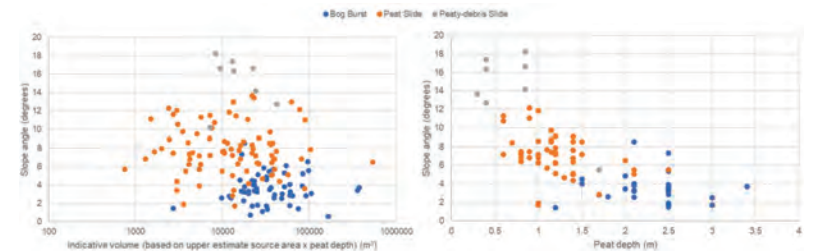
Plate 2.2 Reported slope angles and peat depths associated with peat slides and bog bursts (from literature review of locations, depths and slope angles, after Mills, 2002)

For the purposes of this assessment, landslide classification is simplified and split into three main types, typical examples of which are shown in Plate 2.1. Dimensions, slope angles and peat depths are drawn from charts presented in Evans and Warburton (2007). The term “peat slide” is used to refer to large-scale (typically less than 10,000 of cubic metres) landslides in which failure initiates as large rafts of material which subsequently break down into smaller blocks and slurry. Peat slides occur ‘top-down’ from the point of initiation on a slope in thinner peats (between 0.5m and 1.5m) and on moderate slope angles (typically 5°-15°, see Plate 2.2).

Due to the combination of moderate slopes and thinner peat at the Site, the most likely mode of failure is peat slides, and this is the failure mechanism considered in this report. This is in keeping with the most likely mode of failure for the peat depths and slope angles present at the Site (see Plate 2.2 and Figures 7.4.2 and 7.4.5).

Slope range (°)	Association with instability	Peat slide
≤2.5	Slope angle ranges for peat slides are based on lower and upper limiting angles for observations of occurrence (see Plate 2.2 and increase with increasing slope angle until the upper limiting angle e.g. peat slides are not observed on slopes <2.5°)	0
2.5 - 5.0		1
5.0 – 7.5		3
7.5 - 10.0		3
10 – 15.0		3
>15.0		3

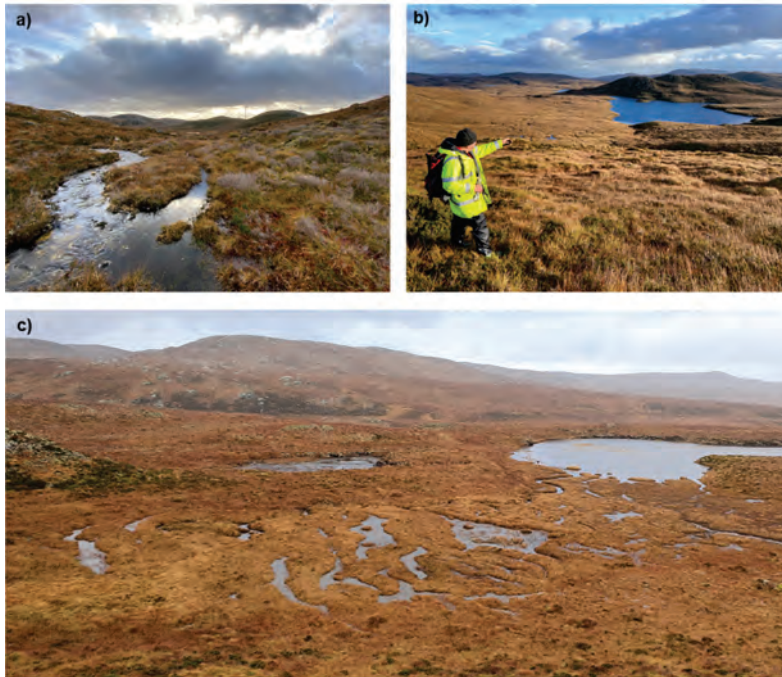
Plate 3.2 a) A typical low gradient watercourse between lochs in the centre of the Site, b) a moderate planar hillside falling towards a loch, c) arcuate bog pools indicating a possible former minor peat displacement on an area of negligible gradient

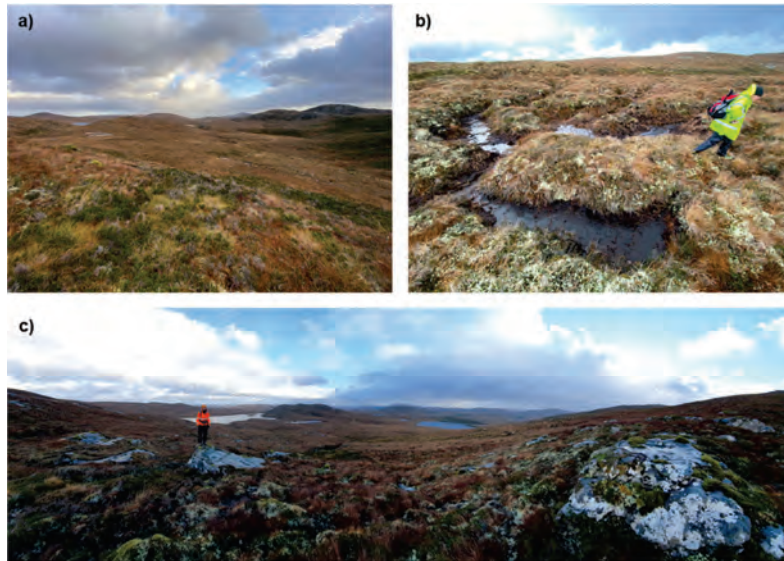
Plate 3.3 a) a typical area of open slope with local rocky outcrops, b) lightly degraded haggged terrain, c) an area of extensive rocky outcrops with shallow peat in-between

The geomorphology of the Site is relatively complex with numerous areas of patchy rock outcrop with thin peat or soil interspersed amongst wider areas of planar peat on sideslopes (see Plate 3.3 for typical ground conditions). Areas of steeper slope frequently exhibit soil terracing (indicative of creep, but not mass movement) and being drier are often heather covered.

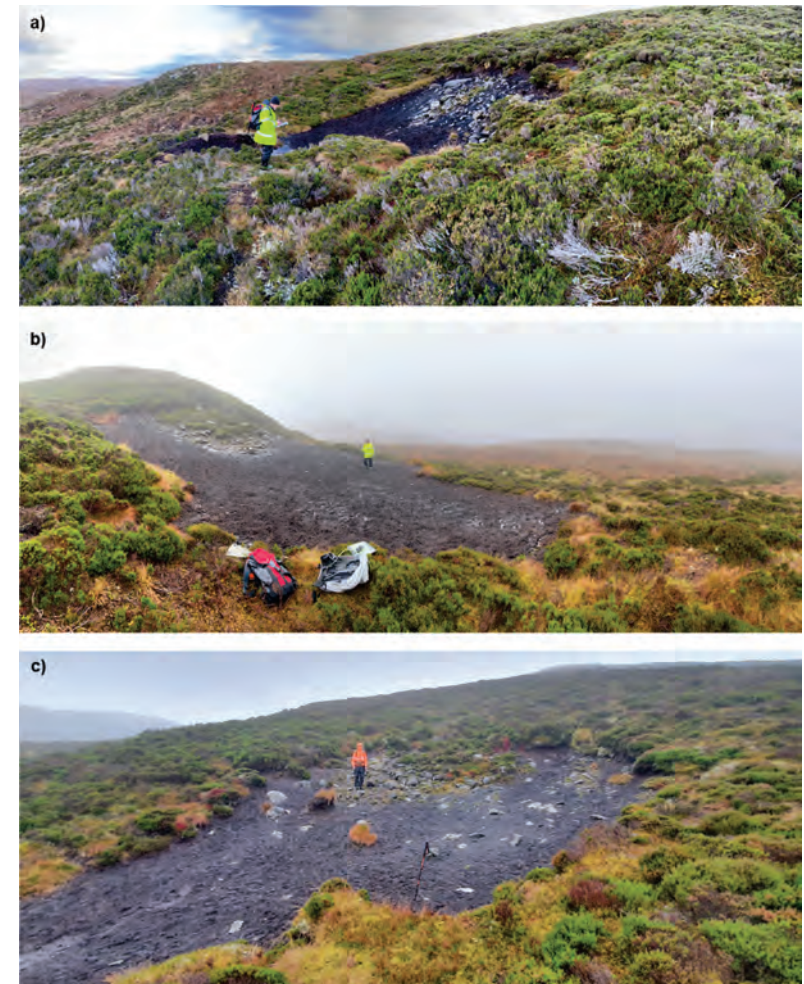
Plate 3.4 a) a shallow peaty-soil slide on a moderate slope (c. 300 m east of Turbine 13), b) a larger but shallower failure (on north-facing slope south of the southern Loch nam Meur) c. 30 m in length with little residual evidence of landslide debris (therefore it is possibly older than the failure shown in a), c) another small peaty-soil slide with peat depth <0.5m at the headscarp (c. 250 m southwest of Turbine 3)

Four minor instability features were observed during site walkover, although only one of these is located in proximity to the infrastructure (to the southeast of the floating track section between the track linking the spurs to Turbines 3 and 4). This feature appeared as minor cracking only. The others features are shown on Plate 3.4 and correspond to peaty-soil slides, with marginal peat depths at or just under 0.5m. They occur on locally moderate slopes, typically where bedrock is immediately beneath the peat and the contact between the peat soil and bedrock is particularly smooth. They lack the large-scale morphology of bona-fide peat landslides (e.g. rafting, blocks, etc) and are more indicative of minor instability than true large-scale peat landslide morphology.

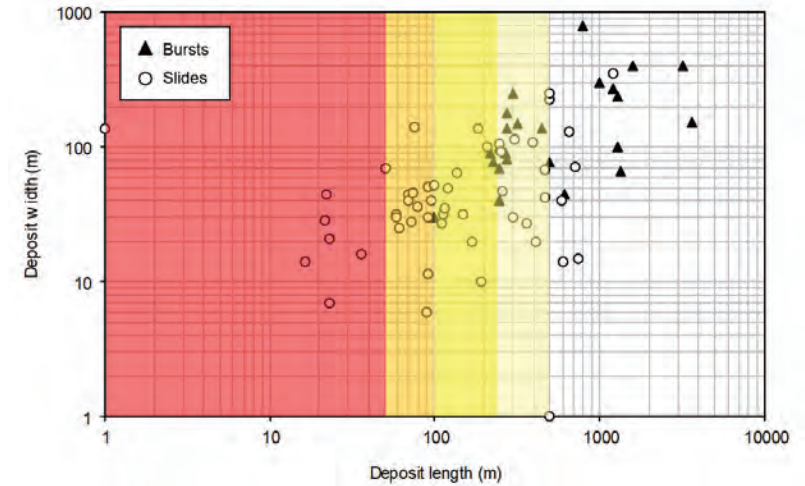
Plate 5.1 Runout distances for published peat landslides (after Mills, 2002), colours on the plot correspond to runout pathway zones on Figure 7.4.9

Plate 5.1 shows runout distances based on published literature. Typically, runout distances would be expected to be less where slope angles decline with distance from the source zone (i.e. on concave

slopes) whereas the full runout lengths shown on Plate 5.1 may be achievable on steepening (convex) slopes or rectilinear slopes. The slope below the source zone down to the minor watercourse is relatively continuous and no restrictions on runout from topography are expected. Runout will likely be arrested by the lochan rather than slope distance.
