Alleston Solar Farm, Pembrokeshire

Arboricultural Impact Assessment

Reference Number: 3.0.6

October 2024

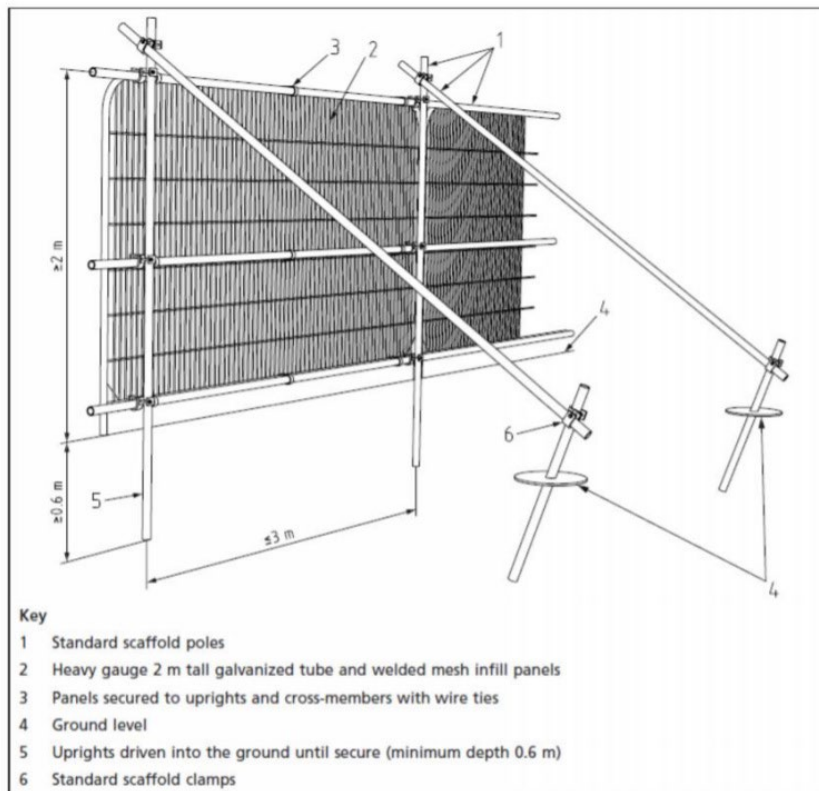
Figure 1: Tree protection fencing example

- 6.1.3 In line with Section 6.2.2 of BS 5837:2012, which requires that the tree protection barriers be fit for the purpose of excluding construction activity and that they provide adequate protection to the trees, hedgerows and woodland, fencing should consist of 2m tall, welded mesh panels (Heras fencing or similar) fixed to the ground via vertical tubes driven into the ground until secure. These tubes should be spaced at a maximum interval of 3m. Each panel will be secured to its neighbour with a minimum of 2 anti-tamper couplers. Where space allows, the panels should be supported on the inner side by stabilizer struts which are attached to a base plate and secured with ground pins. An example of this type of barrier is shown in Figure 1 below.

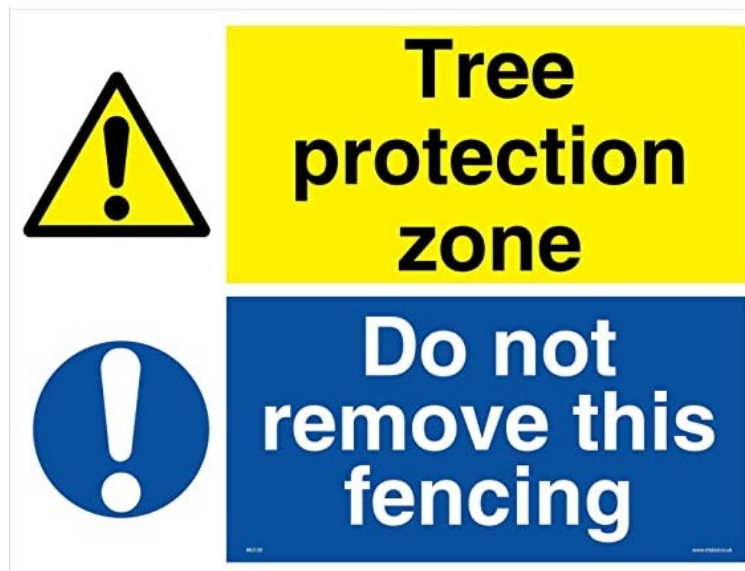
Figure 2: All-weather notice example

- 6.1.4 To clearly identify the purpose of protective fencing on site, all-weather notices will be attached to the barriers similar to the example shown in Figure 2 below.
